Mitigation Assessment Team Report

Hurricane Ike in Texas and Louisiana

Building Performance Observations, Recommendations, and Technical Guidance

FEMA P-757 / April 2009

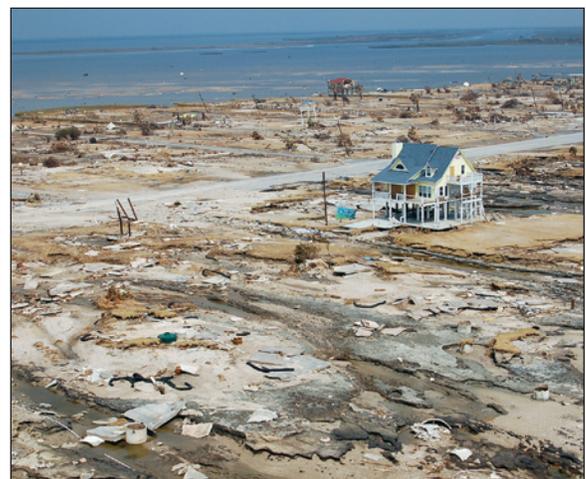
In this photo taken by the MAT on September 19, 2008, a lone house in the Gilchrist neighborhood on the Bolivar Peninsula in Texas, survived Hurricane Ike.
